**Freightliner  
 Service Bulletin**

Some SAM Chassis modules have experienced water intrusion due to the access cover not closing securely. Water intrusion can cause corrosion at the fuse and relay terminals, which can permanently damage the ECU. A new SAM Chassis access cover is available that provides better protection against water intrusion. Use the instructions in this bulletin to install the cover.

## SAM Chassis Access Cover Replacement

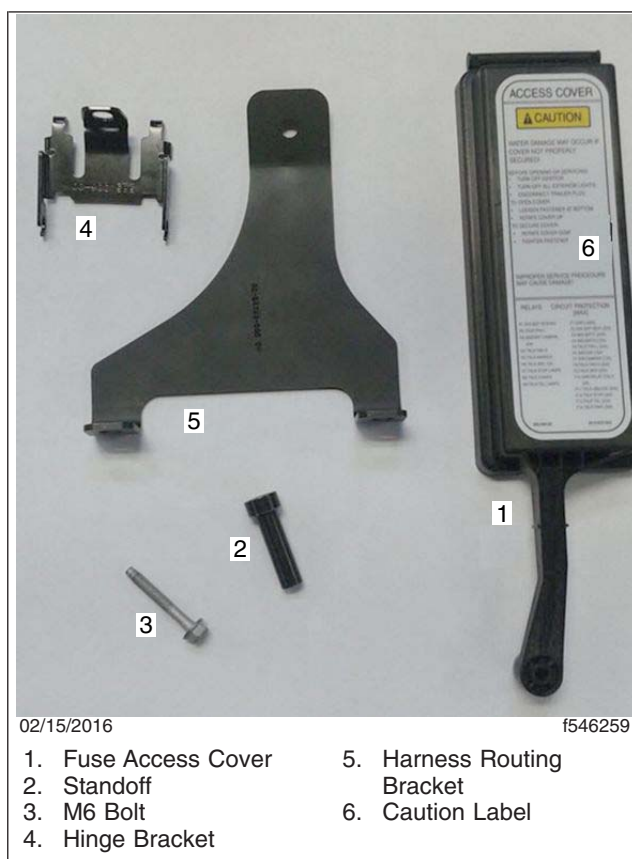
**Fig. 1, SAM Chassis Cover Parts**

See [Fig. 1](#) and [Table 1](#) for SAM Chassis cover parts.

Parts		
Item	Description	Part Number
1	Fuse Access Cover	06-94814-000
2	Standoff	06-94814-002
3	M6 Bolt	06-94814-003

Parts		
Item	Description	Part Number
4	Hinge Bracket	06-94814-001
5	Harness Routing Bracket	06-94783-000
6	Caution Label (on item 1)	24-01872-000
7	Tie Strap (not shown)	23-14137-000

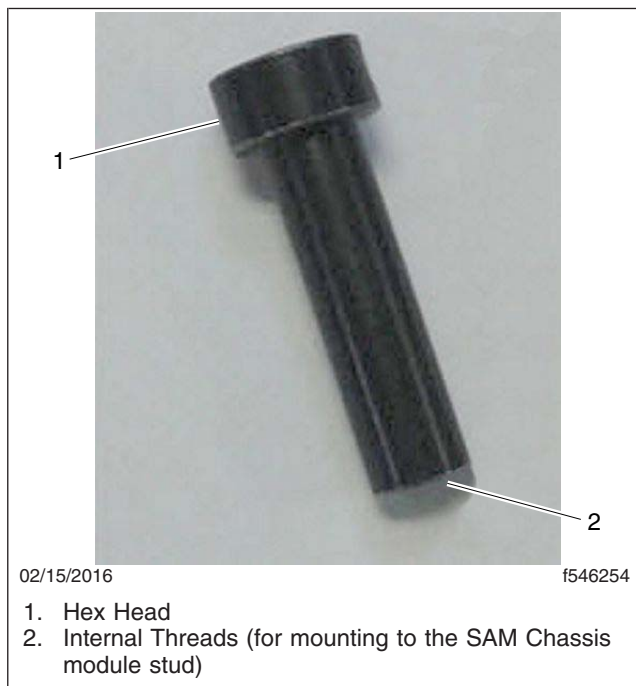
**Fig. 3, Standoff**

6. Install the standoff ( **Fig. 3** ) on the SAM Chassis module bottom mounting stud and tighten to 20 lbf-ft (27 N-m) using a 10 mm hex bit socket.

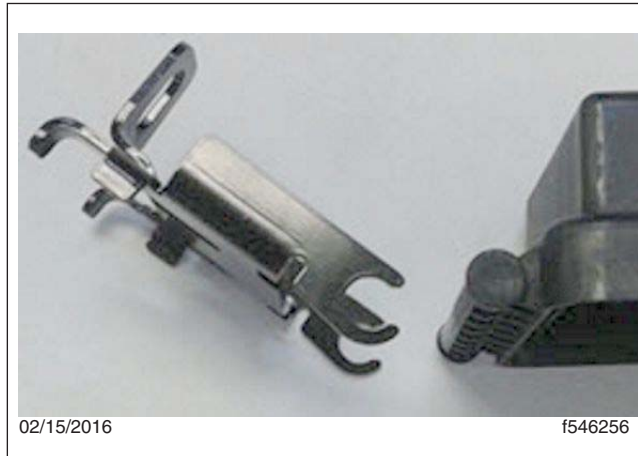
**Fig. 5, Hinge Bracket Installation**

9. Attach the new access cover to the hinge bracket *before* attaching the assembly to the SAM Chassis. See [Fig. 5](#) and [Fig. 6](#). Mounting the cover to the hinge bracket requires it to be rotated in such a way that the flat parts of the cover hinge pins can pass through the hinge bracket jaws. When properly attached, the hinge bracket can be rotated 90 degrees (relative to the cover). This allows the bolt hole to be positioned above the top of the cover, and oriented away from the front, allowing it to recess into the mounting foot on the SAM Chassis when the cover is installed.
